ANGELICA CREEK PARK RESTORATION PROJECT

Monitoring Report: Results of 2008 Monitoring Events

Angelica Creek Park, Reading, Berks County, Pennsylvania

February 2009

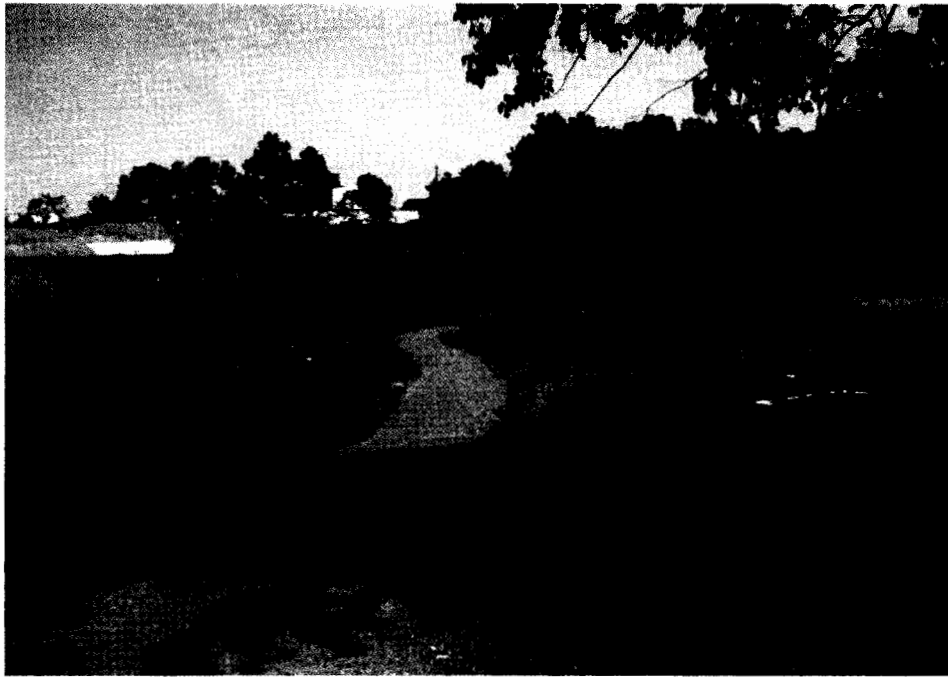
Photograph 5: View of the upland meadow adjacent to Wetland 1, along the gravel path leading to the boardwalk (August 2008).

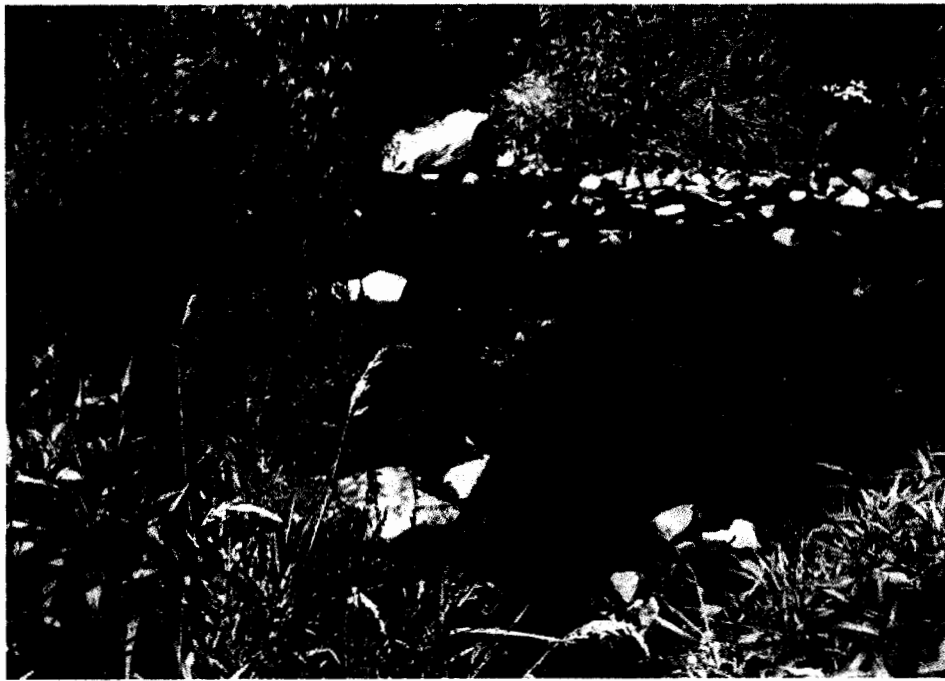
Photograph 7: View of Rock Cross Vane #2 (RV2), from the southern banks of Angelica Creek, facing northwest across the waterway (August 2008).

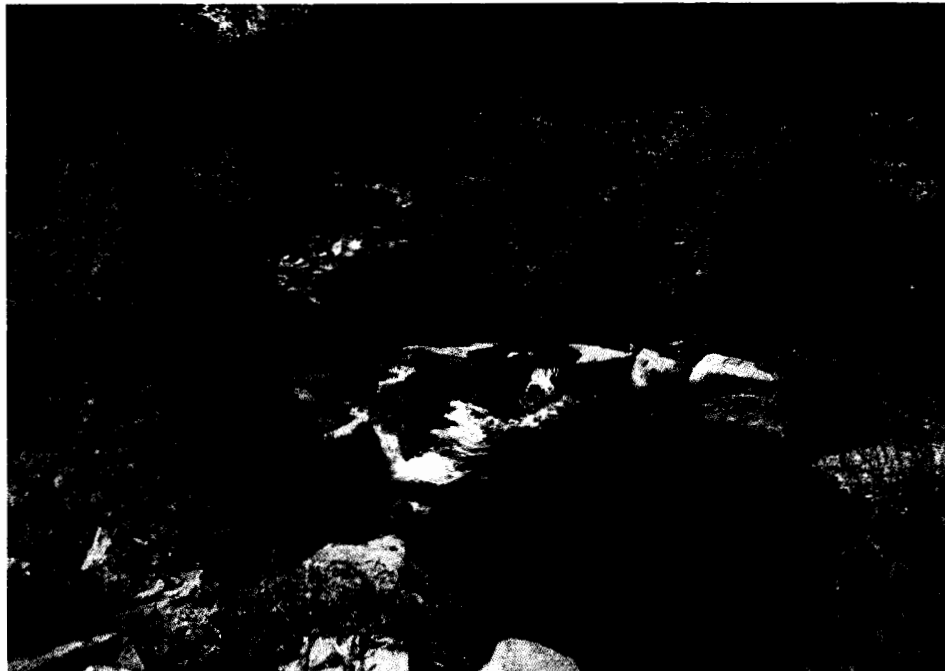
Photograph 8: View of Rock Cross Vane #3 (RV3), from the southern banks of Angelica Creek, facing southwest. This vane has significant erosion that may be affecting the hydrology of Wetland 1 (August 2008).

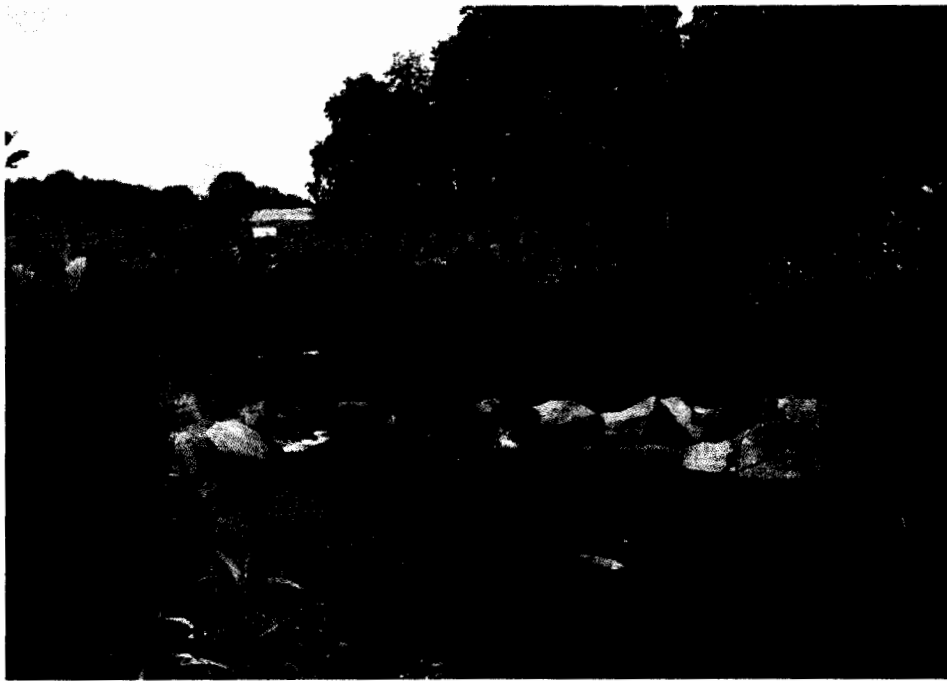
Photograph 9: View of Rock Cross Vane #4 (RV4) from the southern banks of Angelica Creek, facing northwest (August 2008).

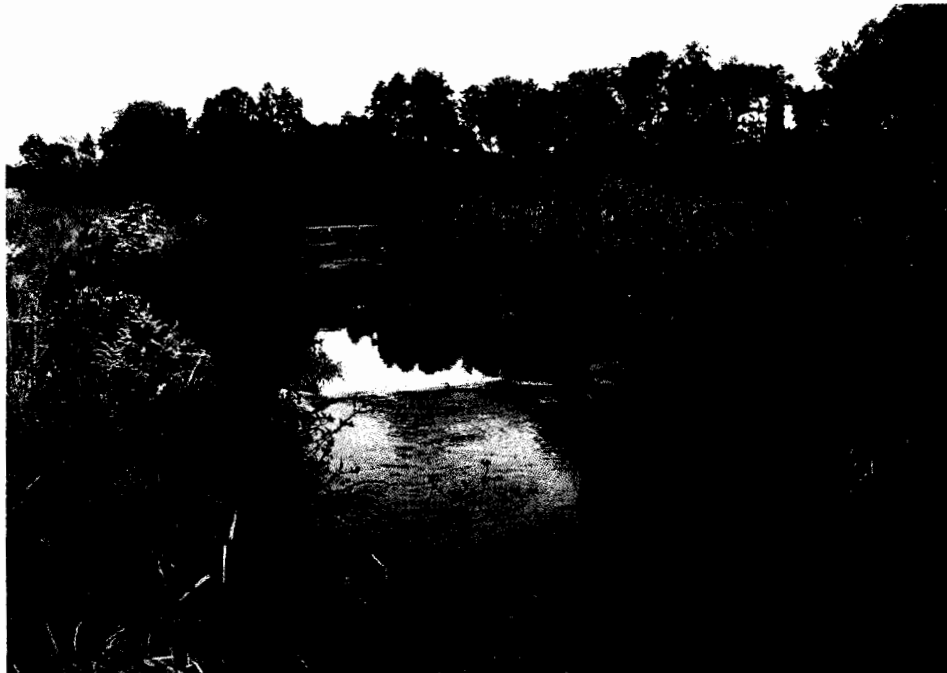
Photograph 10: View of Rock Cross Vane #5 (RV5) from the southern banks of Angelica Creek, facing northwest toward the pedestrian bridge (September 2008).

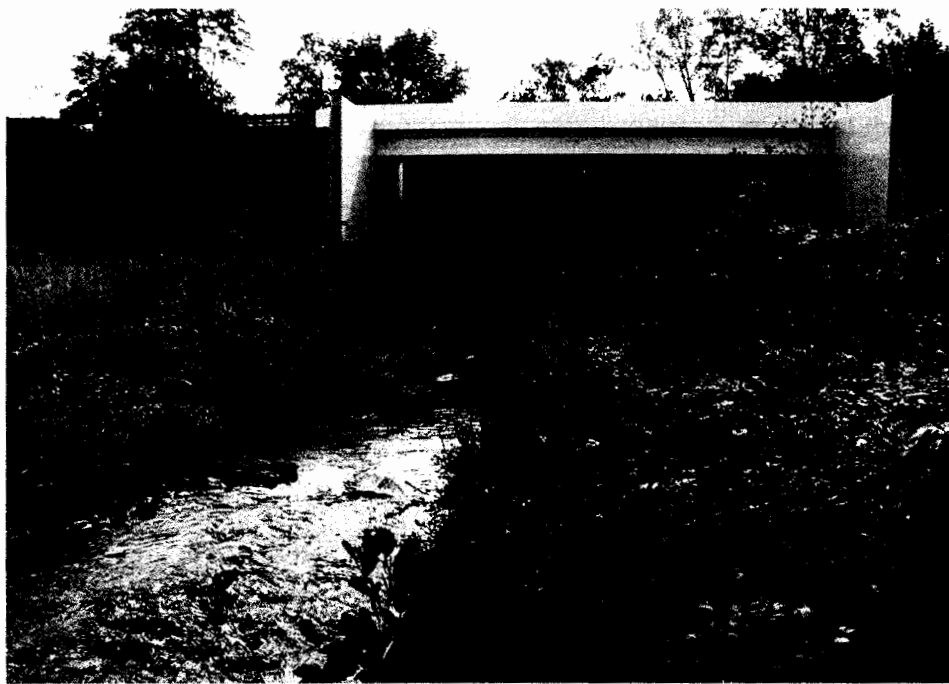
Photograph 11: View of Rock Cross Vane #6 (RV6) from the southern banks of Angelica Creek, facing southeast toward the S.R. 0010 bridge (September 2008).

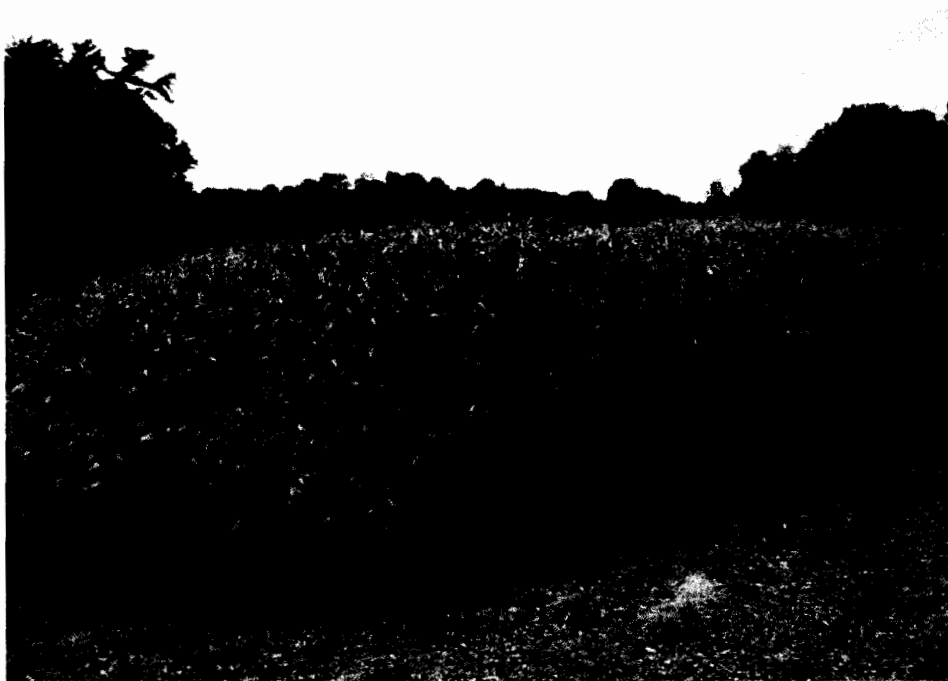
Photograph A: View of the riparian section near the pedestrian bridge, facing northwest. The invasive *Polygonum pensylvanicum* has grown as a monoculture, blocking out other vegetation and the view of the waterway (August 2008).

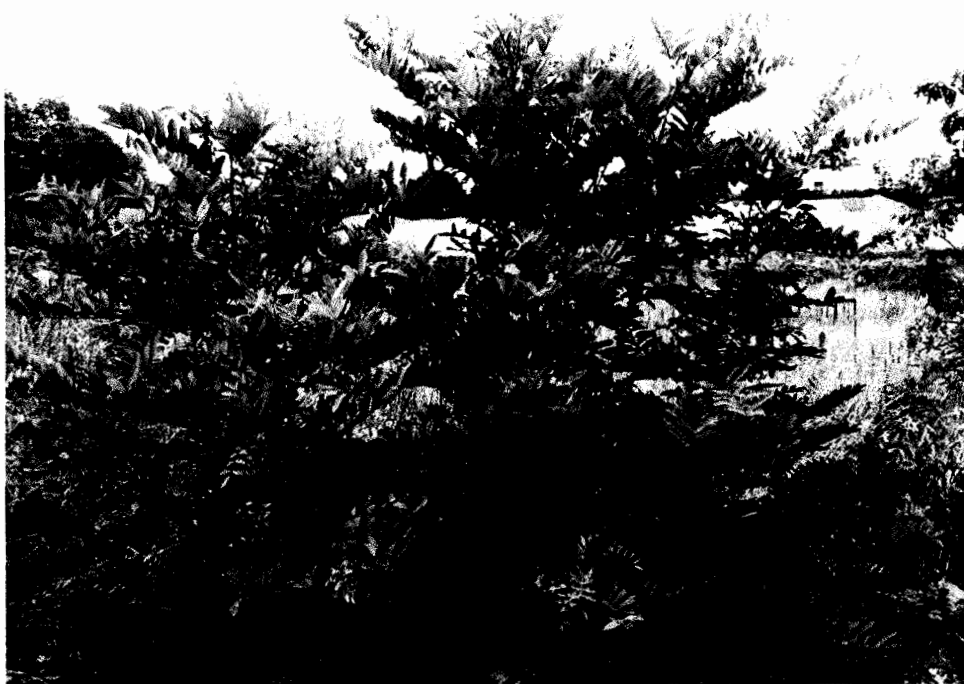
Photograph B: This is an example of a typical specimen of *Robinia pseudoacacia* at the site, after two years of growth. Its rapid growth crowds out other herbaceous and woody species, and its thorns and leaf litter are undesirable for a recreational facility (July 2008).

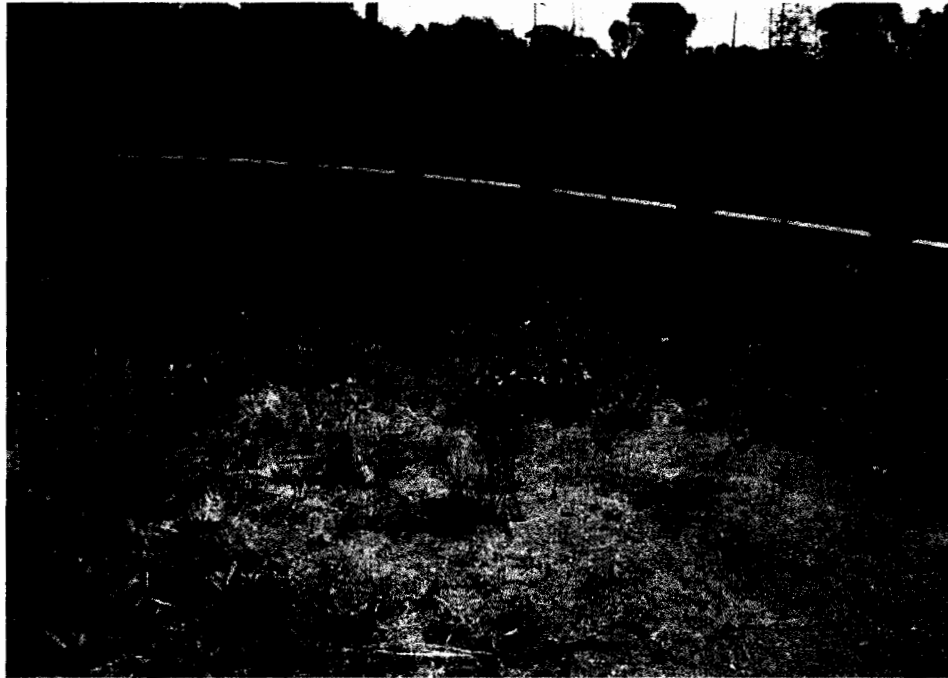
Shrub clusters observed along the riparian riverine zone were overall in very good health with the exception of two *Cornus racemosa* (red-osier dogwood) clusters located on the southern banks of the creek and near the new pedestrian bridge. One cluster of plants showed either signs of accidental cutting by machinery (weed whackers, etc) as part of the trail maintenance, deer browse, or a combination of these two factors. Other individuals within the cluster, farther from the trail, were alive and thriving. A second cluster of red-osier dogwoods appeared to be negatively impacted by gravel and dirt that is eroding from the unpaved construction access road along the hillside. The shrubs in this area show signs of stress including brown leaves and bare branches. The gravel washout may be smothering these plants.

Photograph C: View of the pedestrian bridge from the southern banks of Angelica Creek. Erosion from the gravel construction entrance along the hillside is washing onto the banks, affecting the planted *Cornus amomum* shrubs. This entrance requires either removal or stabilization (August 2008).

0010 bridge) and the new pedestrian bridge, due to gravel washout. If these problems persist, the dogwood shrubs may not survive and replacement would be recommended elsewhere along the streambank.

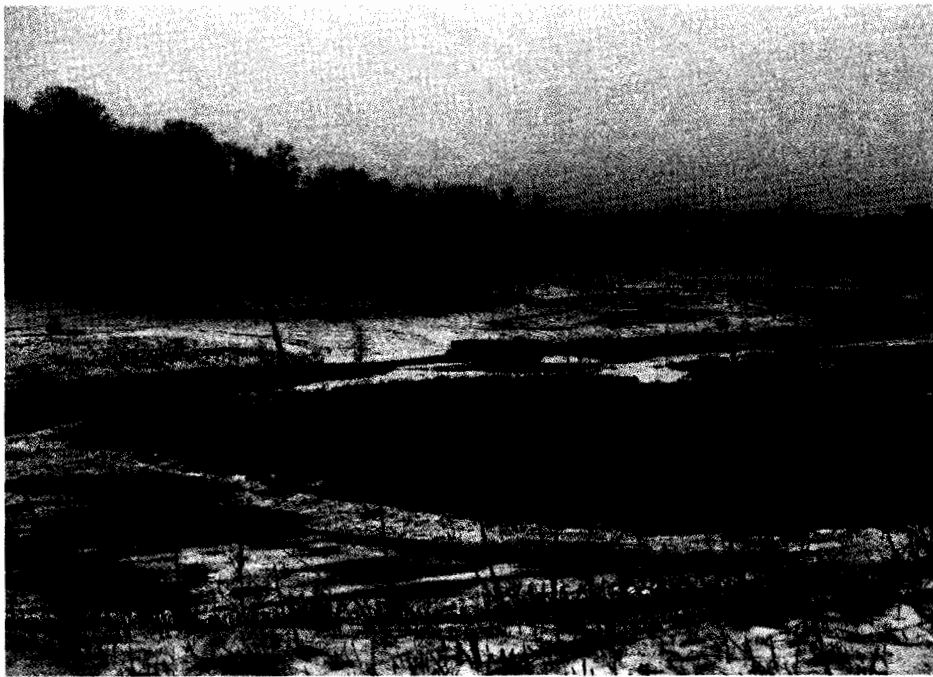
Photograph E: Overview of the Angelica creek site, in the first winter after construction (February 2008).

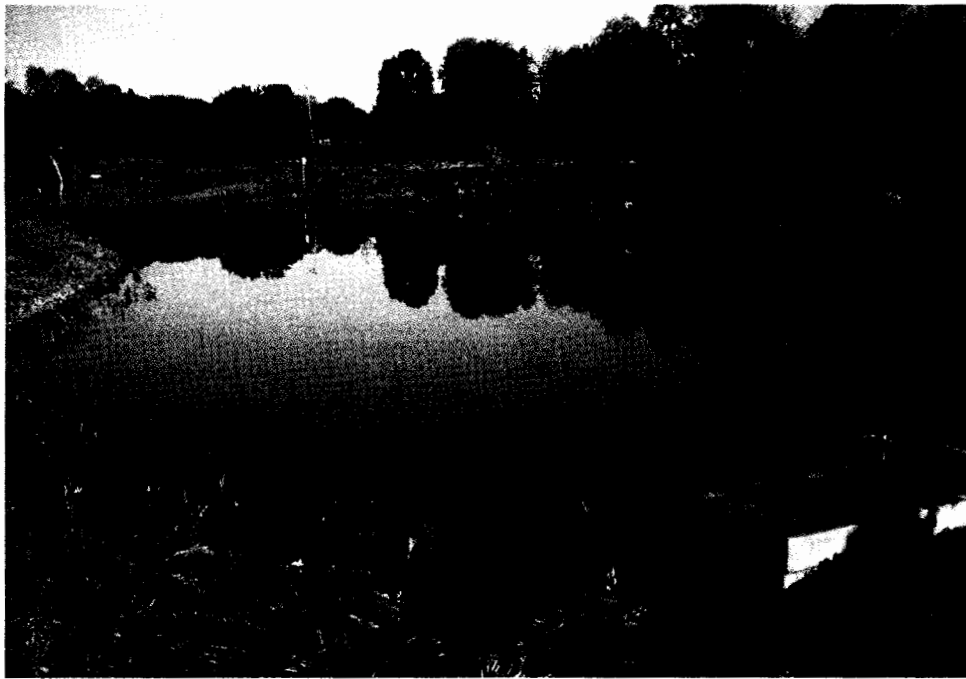
Photograph G: View of the Deep Pond at Wetland 1, from the outlet structure facing northwest (May 2008).

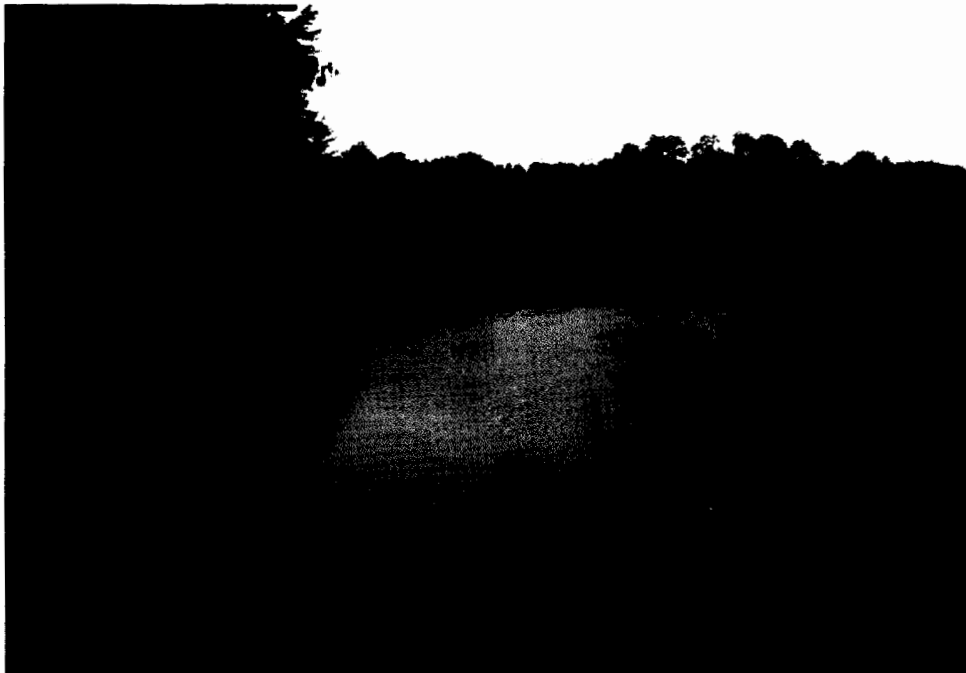
Photograph H: View of the deep pond at Wetland 1, near the outlet structure, facing southwest. A significant amount of vegetation now surrounds the pond (September 2008).

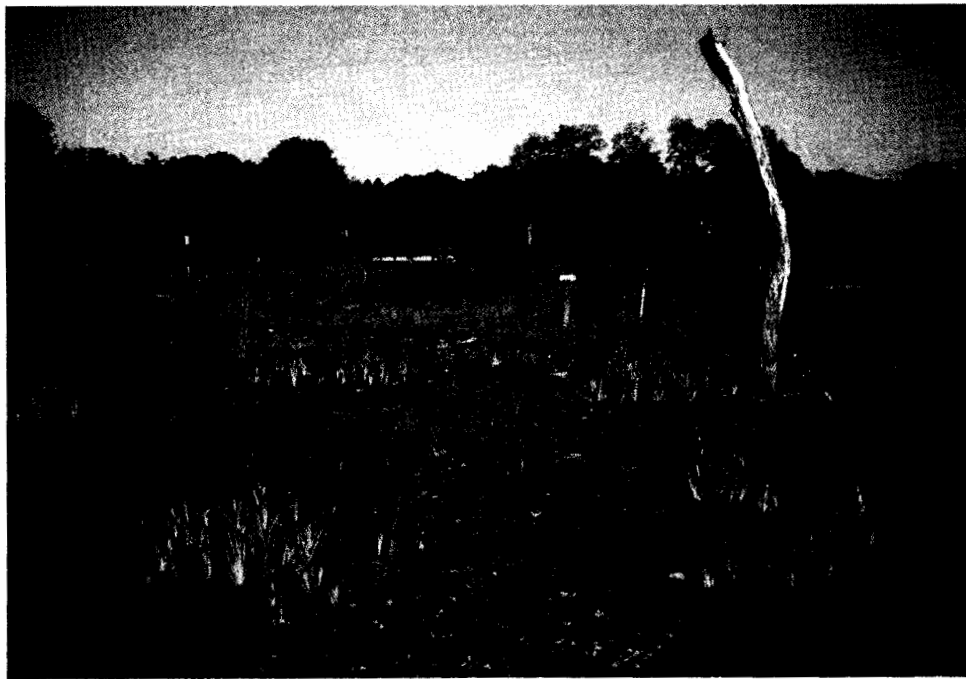
Photograph K: View of Wetland 1, from the boardwalk facing west toward the cement bridge (May 2008).

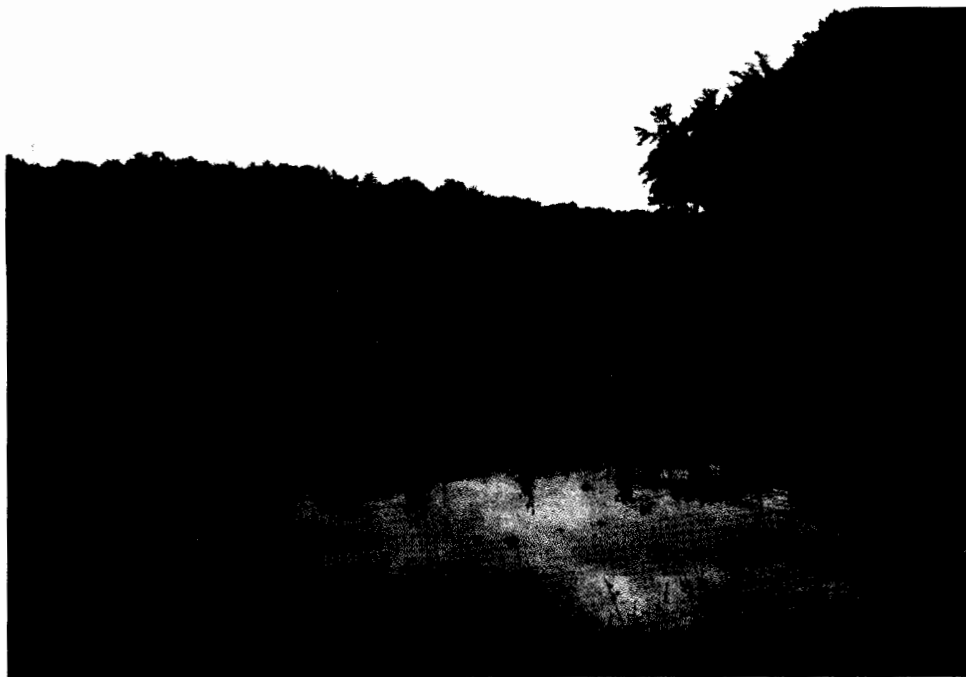
Photograph M: View of the outlet structure of Wetland 1, from the western edge facing southeast. Note the water impounded by the stone wall (May 2008).

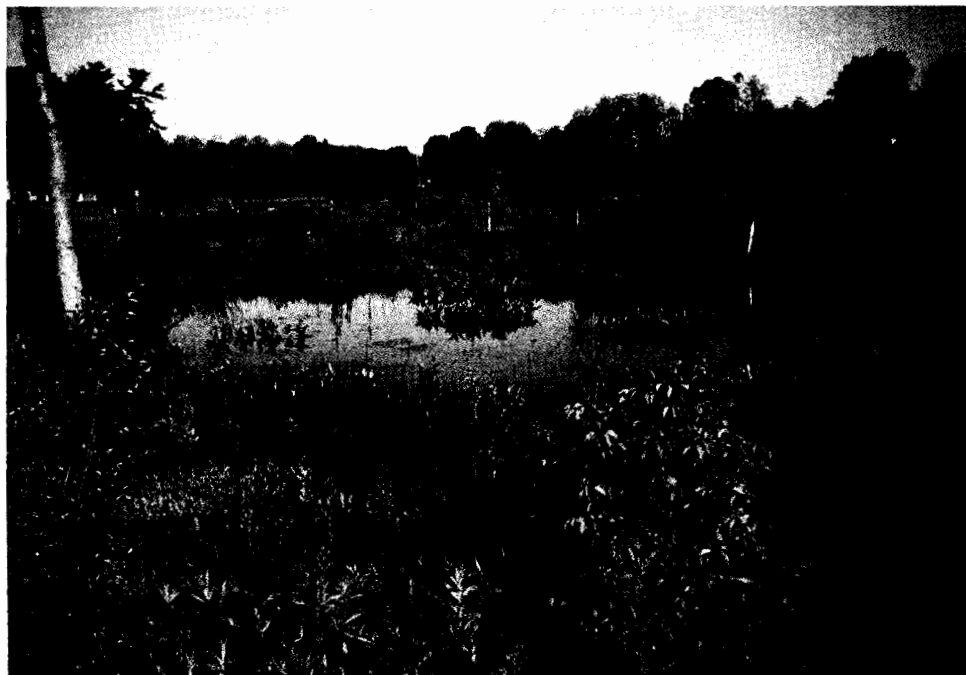
Photograph P: View of the center of Wetland 2 during the spring after construction, facing toward the pedestrian bridge (May 2008).

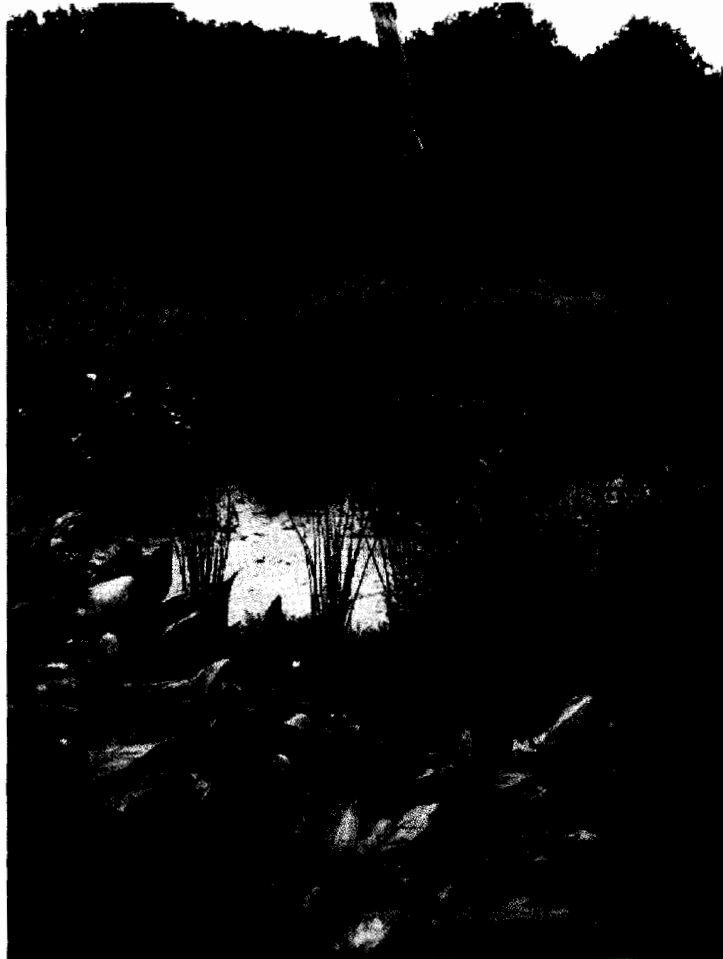
Photograph Q: View of the center of Wetland 2 toward the end of the growing season, facing toward the waterway. This is the only area of Wetland 2 with ponded water (August 2008).

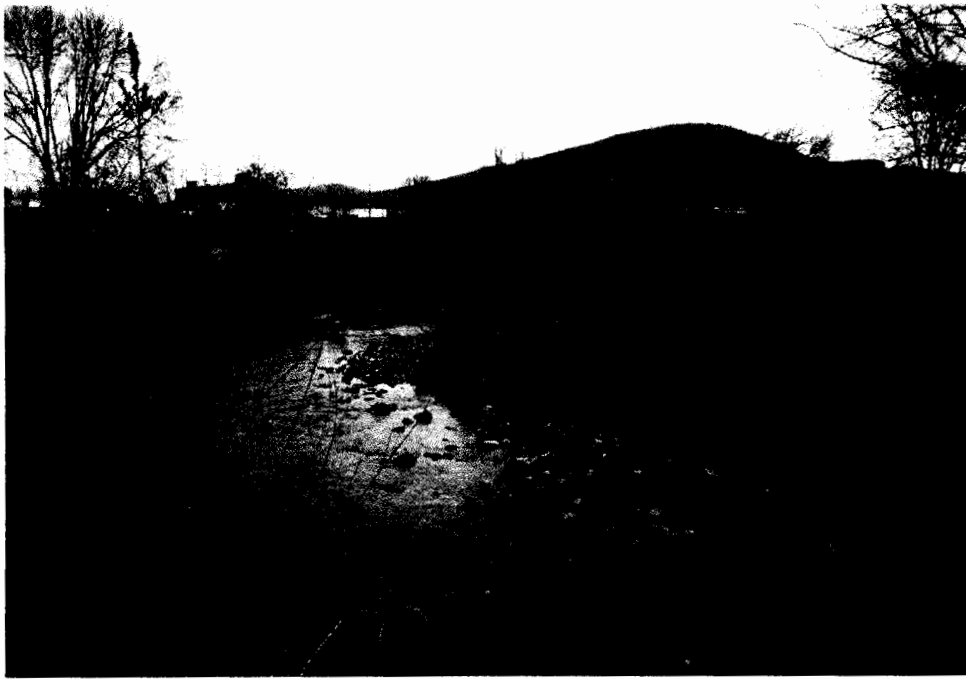
Photograph R: View downstream from the upper limit of the stream restoration corridor. The bridge is the existing pedestrian bridge to Alvernia College. (November 2008).

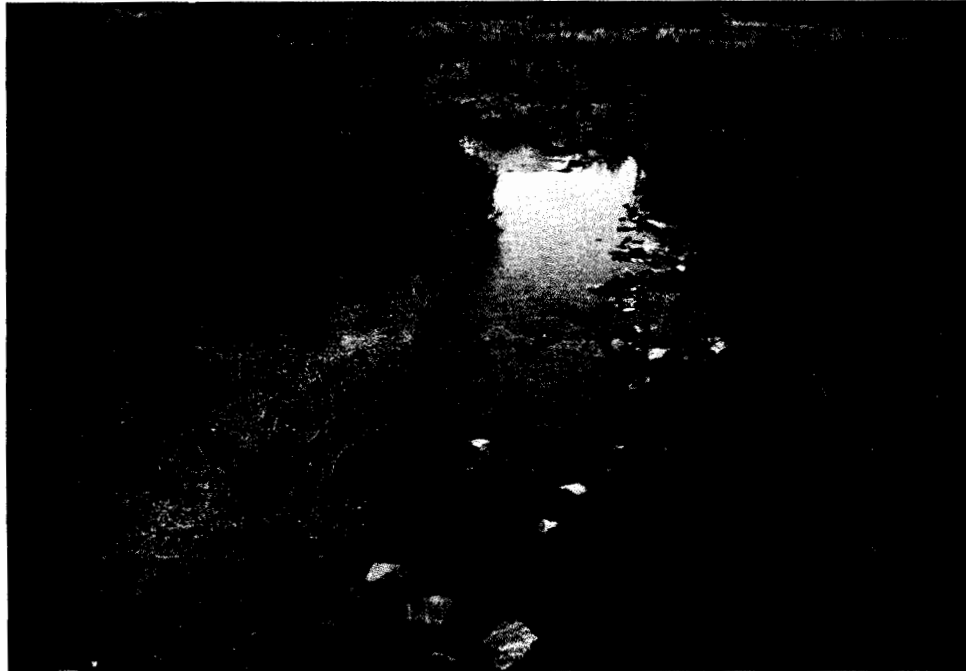
Photograph S: View downstream from the existing pedestrian bridge. Rock Cross Vane #3 is in the center. (November 2008).

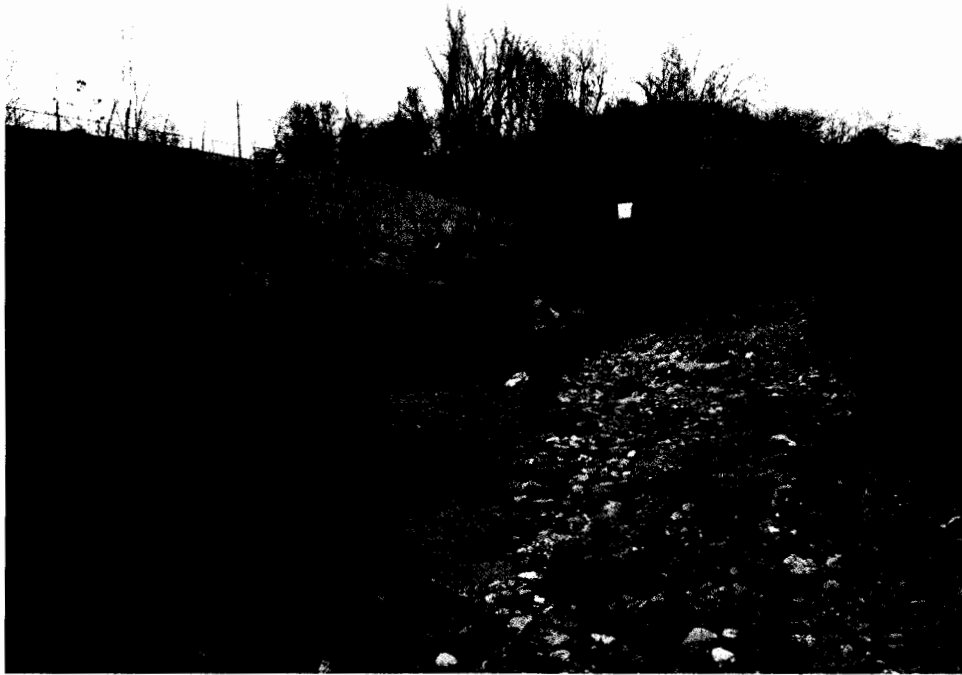
Photograph T: View downstream of Rock Cross Vane #3 towards the section of Angelica Creek that has been undercut. Note that black willows have established on both sides of this area and have stabilized the banks. (November 2008).

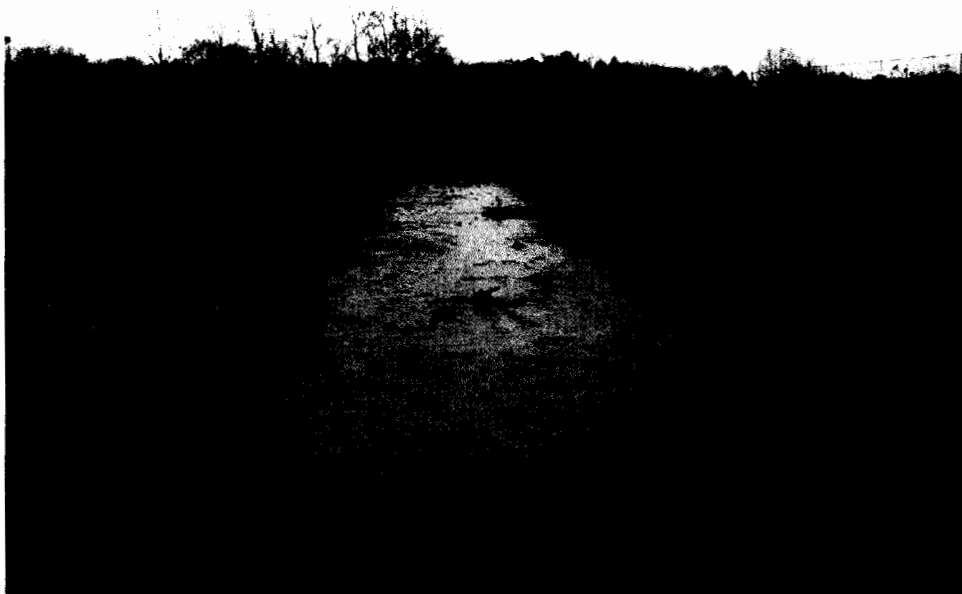
Photograph U: View upstream towards the undercut area. This reach of Angelica creek contains stable banks and dense vegetation. Downstream of the photo location is the new pedestrian bridge. (November 2008).

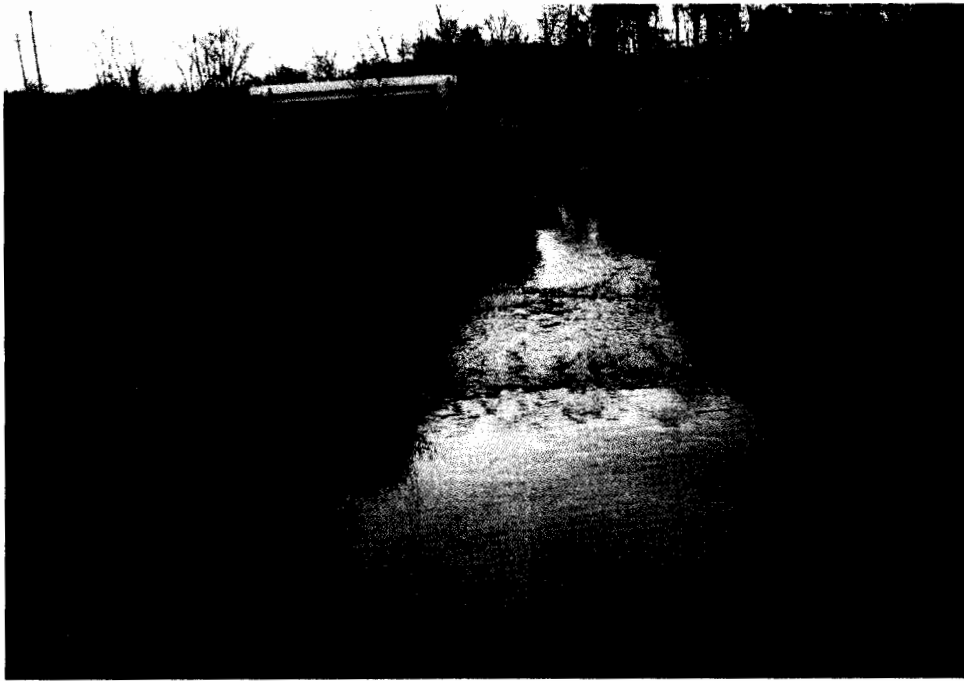
Photograph V: View downstream from the new pedestrian bridge. Note the root was installed on the left bank and Rock Cross Vane #5 in the background. (November 2008).

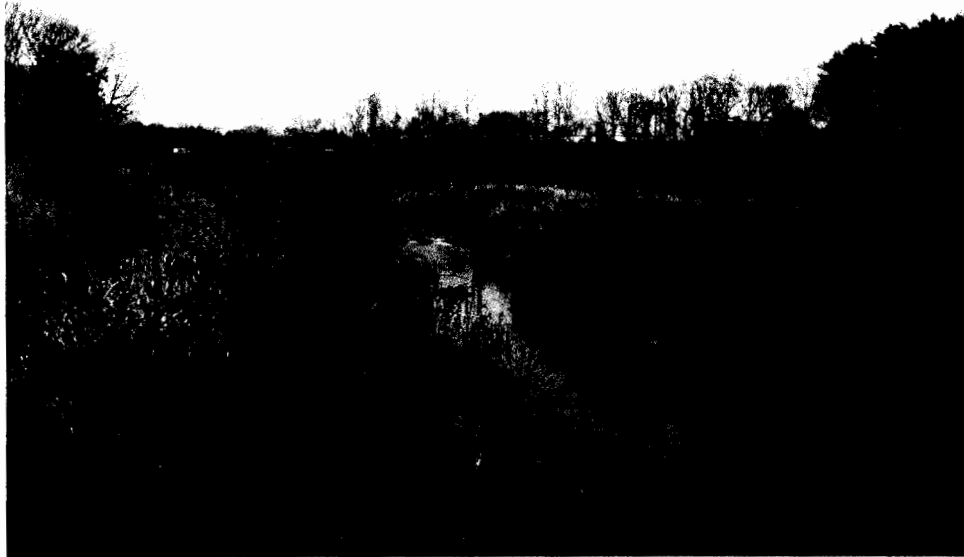
Photograph W: View upstream from the Route 10 overpass. Rock Cross Vane #6 is in the center of the picture. (November 2008).
